Case Study

Faster renewal: Culvert relining, Bolu, Turkey

ViaCon helps reinforce existing culvert faster while giving it a longer lifespan.

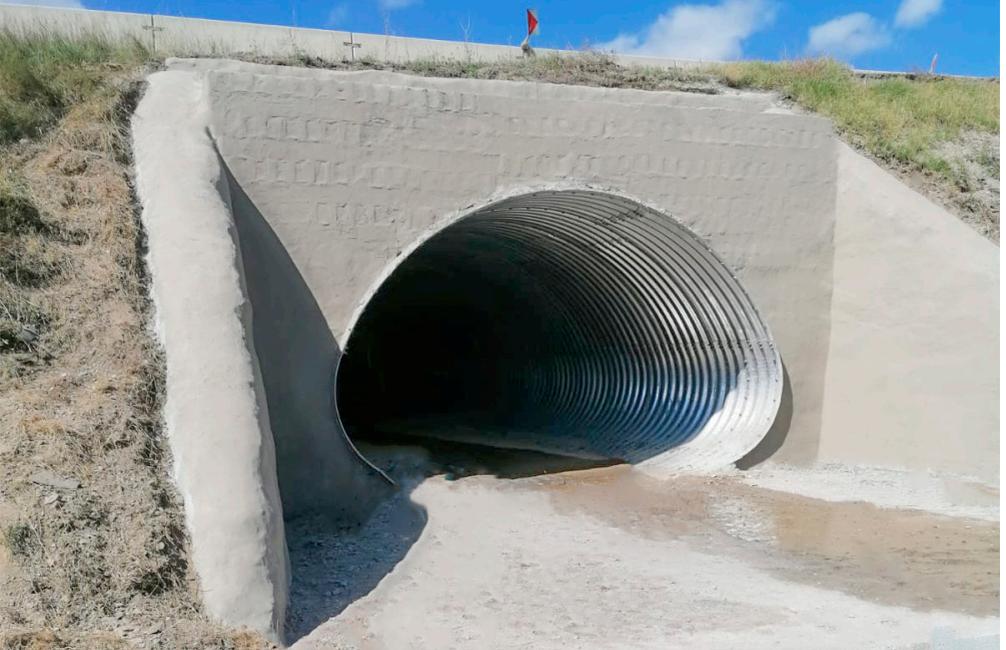
Culvert relining, Bolu, Turkey

A highway culvert in Bolu, Turkey had been in operation for nearly 50 years and was in need of reinforcement after suffering structural damage over the years.

concrete, which would not be fast enough. The planners considered alternatives and decided on a ViaCon corrugated steel culvert system, which was completed in just three days. After that, concrete was injected between the existing concrete culvert and the new steel structure.

This way, the risks arising from structural damage have been eliminated, and the new culvert life was updated to over 75 years.

Size/Profile/Gauge/Shape:
VN12, 5,41 m x 3,32 m
