Case Study

# Renewal without disruption

# Underpass rehabilitation, Siegen-Eisern, Germany

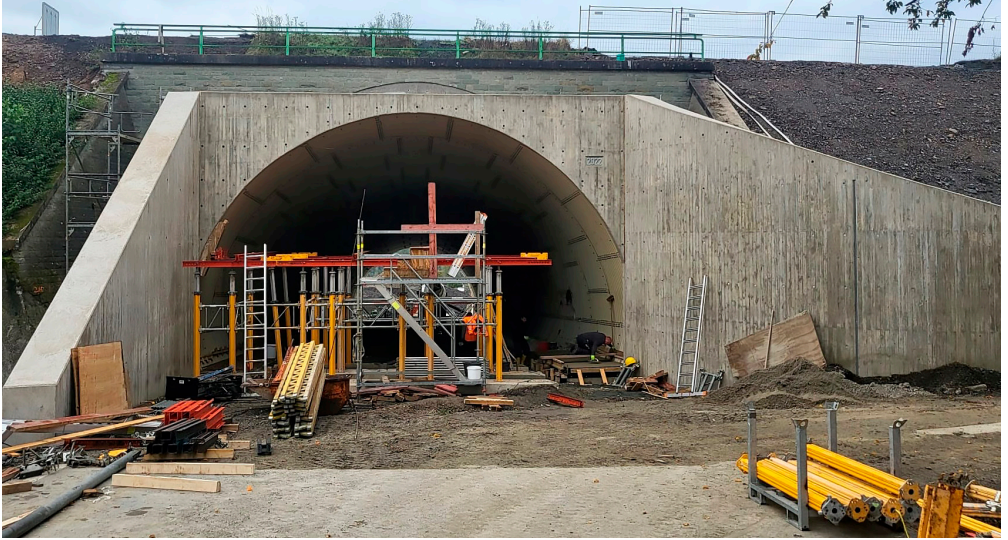
The plan for renewal included a new corrugated steel structure assembled in front of the existing bridge, which was then pulled into the existing bridge.

After completion of the assembly, the remaining space between the old and the new bridge structure was filled in stages so that the corrugated steel structure could withstand the traffic load.
