Case Study

Stream-covering bridge for four-lane highway

Built-fast-to-last Bludov bypass steel buried bridge crossing in Sumperk, Czechia.

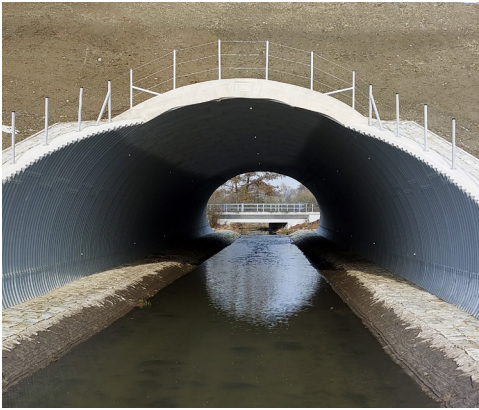
- Multiplate
- Pipe-arch shape with a span of 9.96 m and a rise of 7.32 m
- 8 mm plate and 200 x 55 mm corrugation
- Galvanised

The Bludov stream crossing was crafted of a corrugated steel plate structure of a pipe-arch shape with a span of 9.96 m and a rise of 7.32 m. Due to the large span and the slightly skewed angle of the crossing, 8 mm plate and 200 x 55 mm corrugation was used for the height of cover over 5 m. The ends of the structure were reinforced with a cast-in-place concrete collar, which was done prior the backfilling of the assembled structure.
