## Case Study

# Bringing a vital bridge back into service in Poland

Putting safety, aesthetics and environment into focus, a bridge in Sliwice, Poland is brought back to life

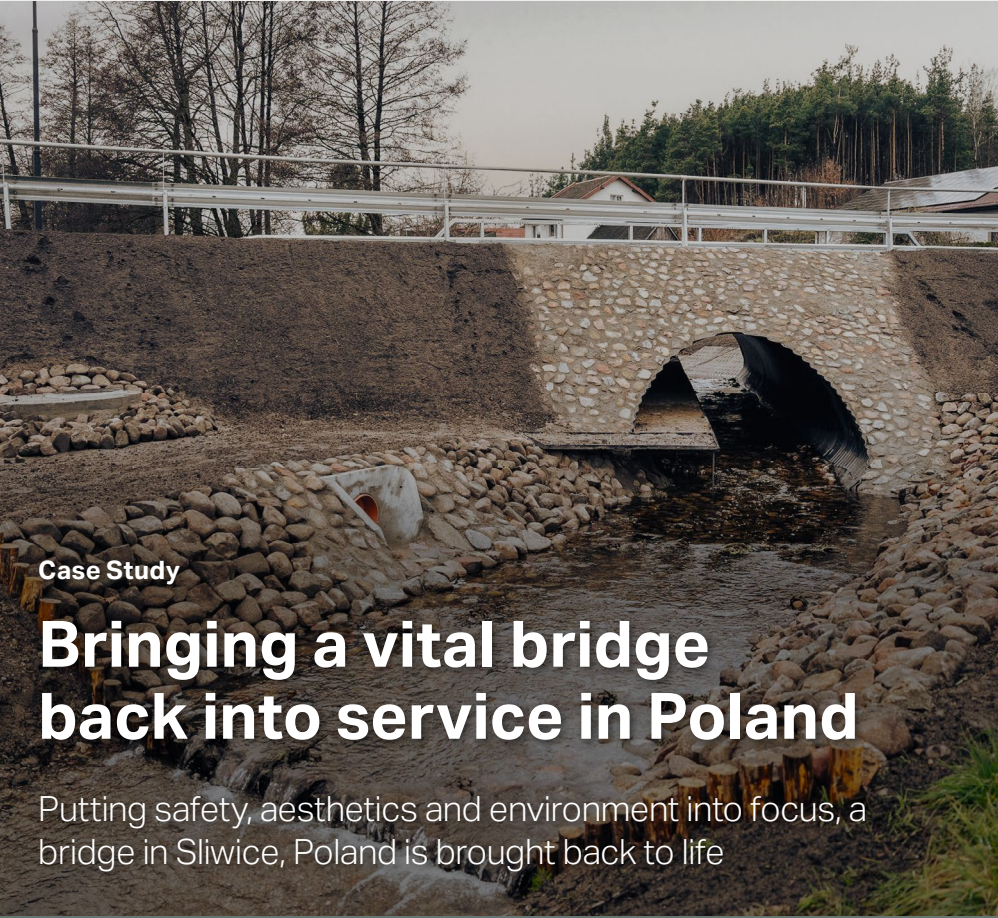
In Sliwice, Poland, a bridge originally built in 1916 and widened in the 1950s faced the challenge of needing to be reconditioned or reconstructed to be considered safe for use. As a critical part of the local transportation network, it was important to bring the bridge up to modern standards and also provide safer, more efficient transport for local residents and through traffic.

Comprehensive reconstruction got underway, and the residents of Sliwice gained access to a modern and safe bridge on Podgorna Street. This investment represented a significant step towards enhancing safety, user comfort, and environmental protection.

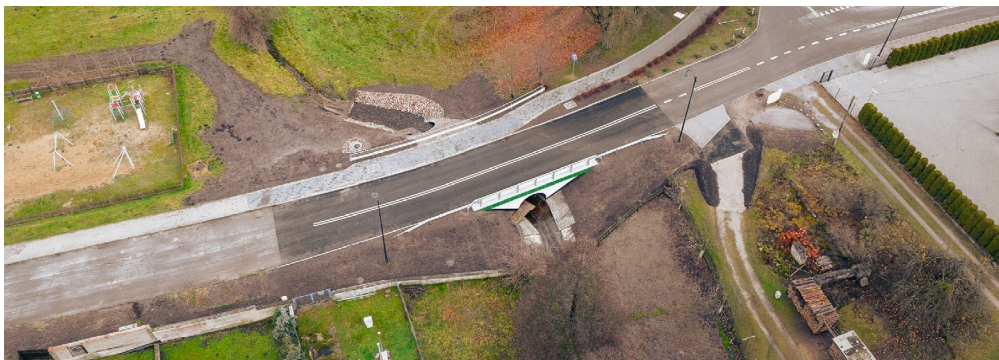
Construction work focused on bringing in modern technology and ecological considerations as a part of the plan. Building work progressed efficiently using spiral corrugated steel pipe, galvanized and coated with a polymer layer, ensuring long-term durability and resistance to corrosion. Furthermore, the bridge was upgraded with modern abutments, pavement, safety barriers, and an advanced drainage system.

To support environmental sustainability, a special steel shelf was installed beneath the bridge, facilitating the migration of small animals. This measure helped preserve natural movement corridors for local fauna, demonstrating a thoughtful integration of infrastructure with the surrounding ecosystem.

**Span:** 14.50m

**Rise:** 5.15m

**Profile:** SC-18NA

**Plate thickness:** 7 mm + 5.5mm ribs (full circumference, every second ring)

**Corrugation profile:** 381 x 140 mm

**Corrosion protection:** Zinc coating and epoxy painting inside and outside
