## Case Study

# StormWater tank protects tunnel entrance from flooding

ViaCon delivered a 430 m<sup>3</sup> tank solution in corrugated steel to manage rainwater and road washwater in a major infrastructure project in Sweden.

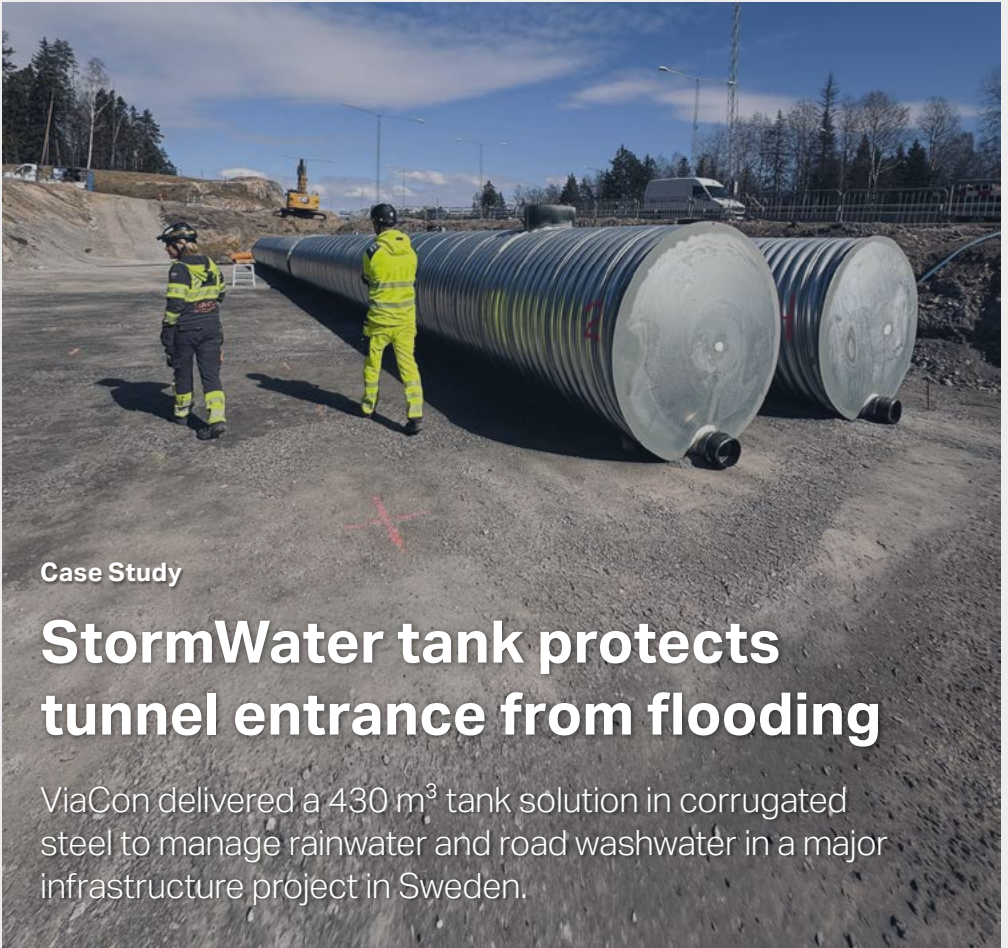
The tank was manufactured in HelCor® hot-dip galvanised corrugated steel, providing a durable solution designed to collect and store water for many years ahead.

The system consisted of five DN1800 pipes, each 33.7 metres long, connected in parallel through a D200 interconnection pipe. This created the required storage volume while offering an efficient and practical solution for the site conditions.

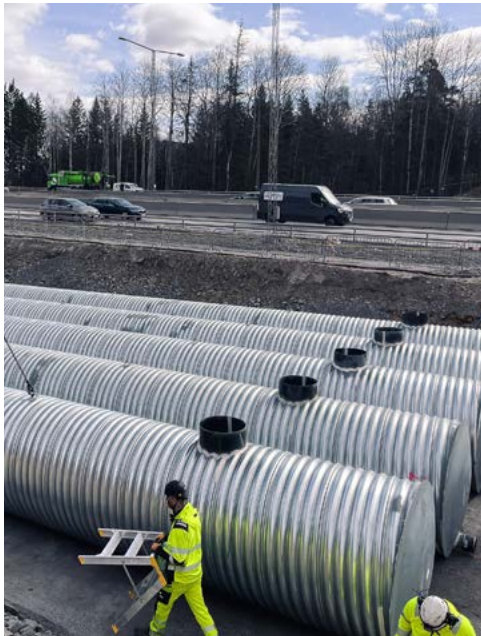
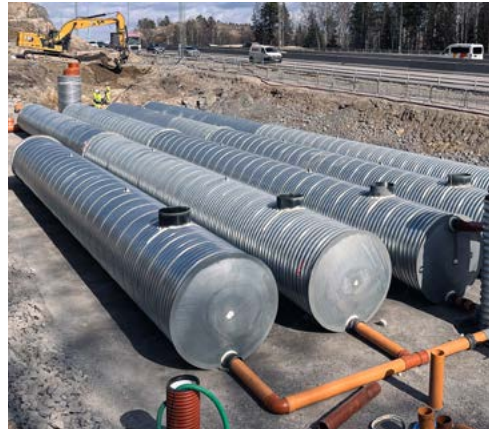
ViaCon also carried out the installation, assembling the pipework on site to ensure an efficient process from delivery to completed solution.

ViaCon delivered a cost-effective solution that met the required retention volume and helped solve a demanding logistics challenge. The full delivery was brought directly into the excavation area, with 12 trucks unloaded on site in a single day.
